## Newest results of LUSITANIA research

Dr. Tamás Balogh, Péter Könczöl

### What the shipwreck tells about - the results of the 2023 expedition

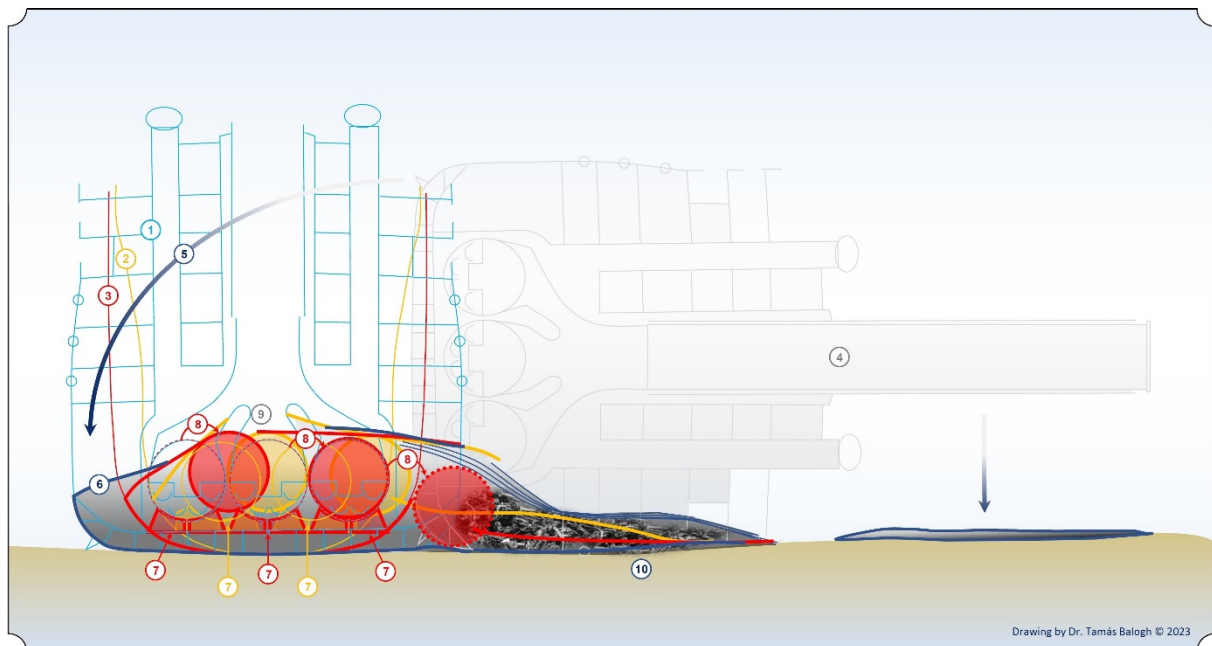
*The ship was lying on her starboard side in the state at the time of the sinking, she was broken in two in the middle and the bow was also damaged (both damages were caused by the same thing: the sinking hull hit the shallow seabed).*

*However, as the corrosion progressed, the sufficient strength was lost, so the structure could no longer keep its original shape and obeyed the compressive force resulting from her own weight and the kinetic energy of the currents, and at first only slightly, but eventually deformed more and more. First the funnels and masts fell, then the elements of the superstructure that originally occupied the highest part of the ship, the deckhouses on the boat deck and the promenade decks collapsed.*

*In the meantime, the hull as a whole slowly moved to the portside and its height also decreased, as the weight of the original portside with reinforced (therefore heavier) plates at the highest point of the wreck was transferred to the deck beams in the hull, which were not designed to withstand this weight.*

*As the deck beams buckled, the compressive force from the weight of the heavy port side was applied to the rigid structure of the double hull, which buckled out more and more until, having only been able to withstand the one-sided pressure for a while, it finally broke (at the junction with the starboard side of the hull), and fell to the seabed, dragging the portside attached to it with itself, so that the height of the shipwreck (the width of the original ship) was reduced by half - from 26 to 13 m.*

**Fig. 3.:** The fate of the sunken ship was already realized by one of the survivors of the disaster, the third officer Albert Bestic, in the May 22, 1922 edition of the "Washington Times", noting that the hull "was probably split in two by the huge impact with which the bow slammed into the bottom. In addition, the engines must have been torn off and the boilers must have fallen forward." American diver John Light, who researched the wrecks between 1960 and 1963, confirmed these assumptions. As can be seen in the 2nd picture, the wreck of the LUSITANIA originally turned to the starboard side of the ship's hull and hit the seabed broken into two pieces. The break was caused by the shallow seabed, which, as it sank, the force of the impact crumpled the bow and split the ship in two in the middle, which, after sinking, tipped over on its starboard side. At some point in the 1980s, the bottom of the ship, standing vertically in this position, largely tilted back to its original, horizontal position, dragging the portside of the ship's hull, which had been high up until then, with it. On the side of the wreck opposite the ship's keel, the decks collapsed and the debris slid down to the seabed.

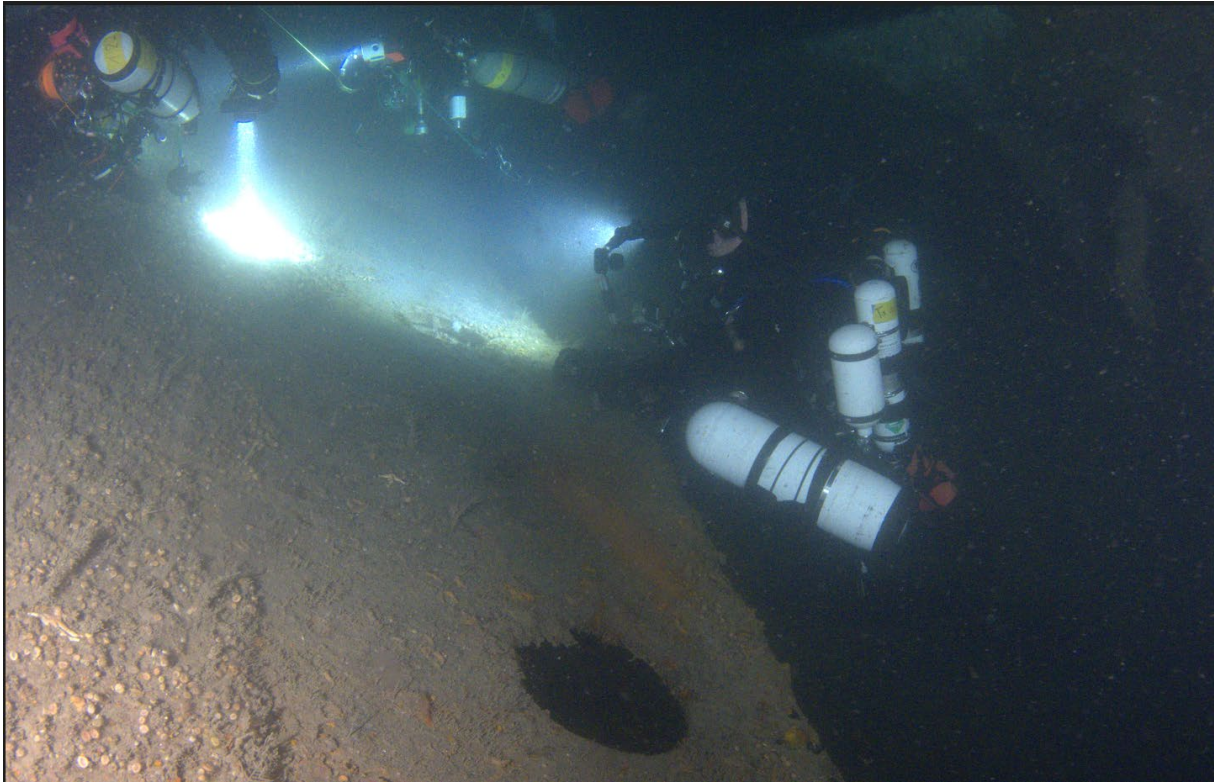
**Fig. 6:** On the portside of the hull, in the original underwater part, a fracture developed between the plates attached to the reinforced frame segments and the conventional parts above the waterline. The plates moved apart horizontally along the fracture and moved vertically relative to each other. This allows the divers to enter the boiler room through the break in the portside plating that had been fall over the boiler room No. 1. Stewart Andrews is pictured doing just that (photo: Pat Coughlan).

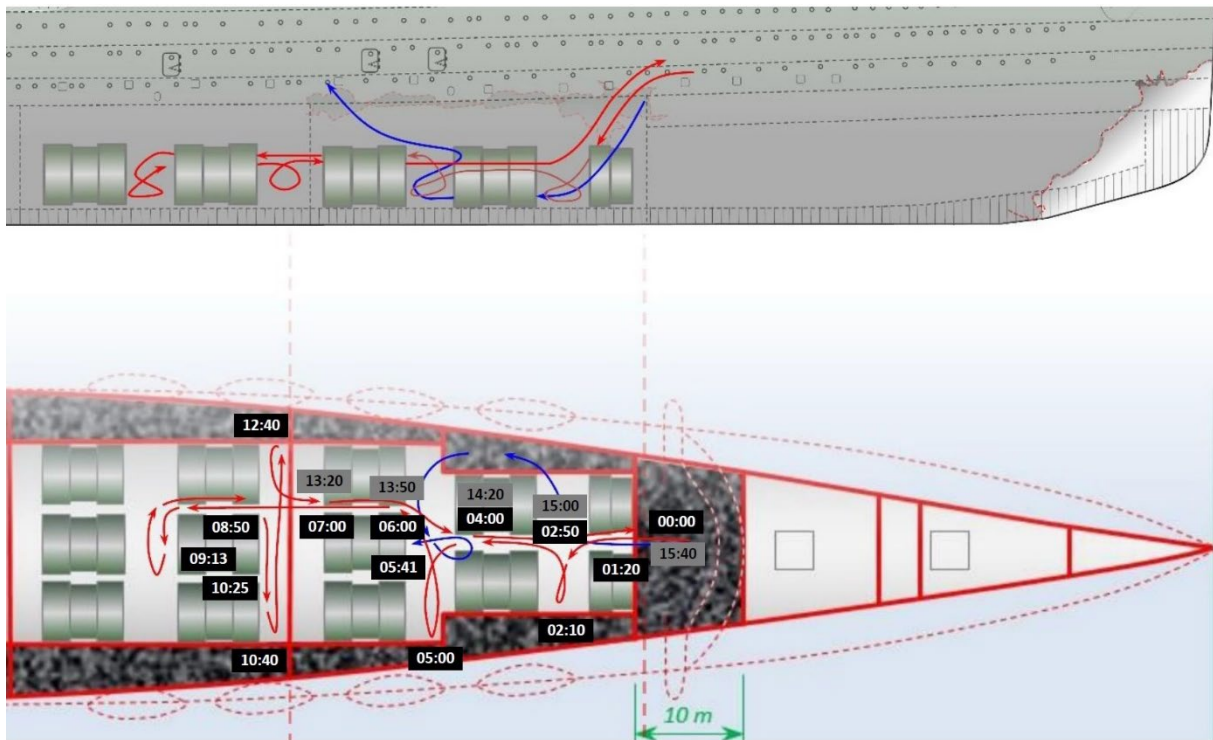
**Fig. 7:** Internal exploration of boiler rooms No. 1 and 2 in 2022 (blue) and 2023 (red).

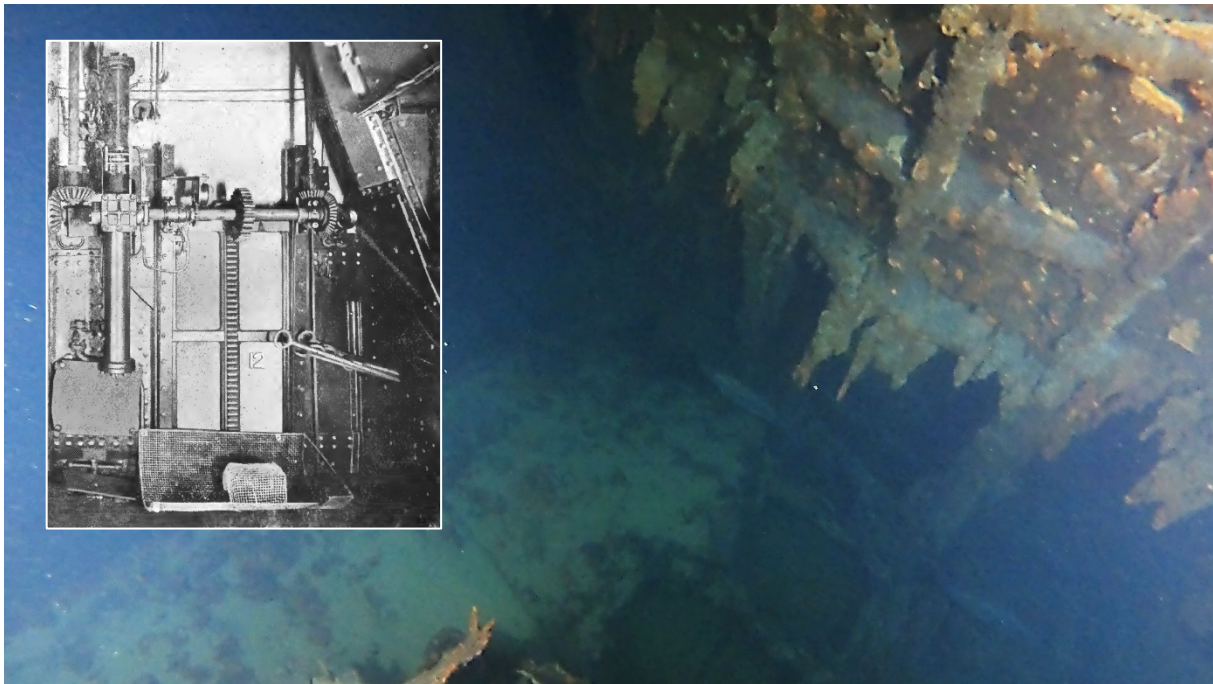
The expedition found a total of four watertight doors in the first two boiler rooms visited and in the reserve (cross) coal bunker (for the very first time in the history of the wrecks' research). Two of these belonged to coal bunkers and two to passageways (from the boiler room No 1. to the reserve coal bunker and from the reserve coal bunker to the forward cargo hold). The expedition was the first who clarified that the doors of the coal bunkers connected to the boiler rooms were open (we did not see all of them, but the ones we saw, were all open). On the other hand, the doors for passageways between the reserve coal bunker and the cargo hold were closed (the door between the boiler room and the reserve coal bunker – that was used as a coal bunker door on the last voyage – was open). This is reasonable if we take into account that even one boiler of the ship consumed 24 kg of coal per minute (3 kg per furnace). A wheelbarrow approx. transports 50-60 kg of coal in one round. So, depending on how many furnaces served by a certain door of the given coal bunker (6, 8 or 10), the trimmers had to return with their wheelbarrows once a minute, but at a maximum of every one minute and a half minutes. Lowering the bulkhead doors between filling and emptying of the wheelbarrows was practically pointless - even impossible. Therefore, in order for the required amount of coal to be continuously available at the boilers, the coal bunker doors were left open, thereby speeding up the loading of coal. The 2022 and 2023 expeditions found evidence of this. All of this is important because the water breaking into boiler room No 1 could have easily entered the coal bunkers of the boiler room through the opened doors (i.e., from the inside), thus creating the 15° list to the starboard side as mentioned by the survivors (that is, it is not at all necessary that the flooding of coal bunkers was only caused by one of the possibilities raised so far - a torpedo hit, a coal dust explosion, or a boiler explosion). It is much more likely that the second explosion contributed only indirectly to the ship's rapid sinking by causing a rapid and critical reduction in the amount of steam to the machinery, which had two consequences: on the one hand, the ship was no longer steerable, as the steam-driven steering engine stopped, on the other hand - and this is more important - it was no longer possible to lower the open doors of coal bunkers, which were not equipped with floats to automatically lower in response to the intruding water, so their closing depended on the functionality of the steam-powered central control system, which, in turn, stopped after the remaining amount of steam fell below the critical level in the system as a result of the second explosion. The intruding water thus quickly flooded the open coal bunkers, significantly increasing the list of the ship.

**Fig. 8:** Watertight door of a coal bunker in closed situation (on the archival picture in the insert) and opened in the boiler room (on the actual underwater photo, which is shot by Stewart Andrews).

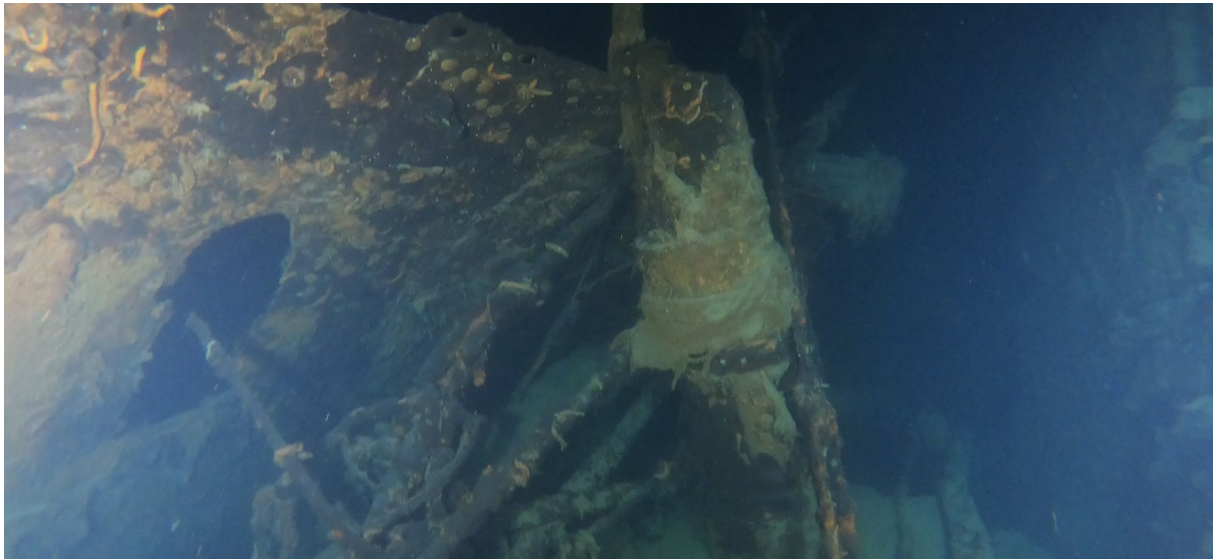
**Of the structural elements delimiting internal spaces, only the remains of the main watertight bulkheads between the boiler rooms are visible.** These remains are lower parts of the bulkheads, approximately to the 1-2 m height. Original strong structural elements (vertical frames supporting the bulkheads and the lowest horizontal stiffener) are visible. However, the plates are also incomplete and strongly corroded on the remaining 1-2 m high section. In case of the bulkhead between boiler room № 1 and the cross (reserve) coal bunker in front of it, this severely deteriorated condition could be justified by the torpedo hit itself, but not in the case of the bulkhead between boiler room № 1 and № 2, of which damage shows the same characteristics as the previous one. The reason for this is probably related to the process of the hull collapse. The bulkheads played a stiffening and supporting role for a while. After arriving at the seafloor, in the wreck lay on her starboard side, the bulkheads, together with the ship, turned 90° to the right compared to their original position, and tried to maintain the portside of the hull which elevated into the highest point of the wreck. However, due to their structure and corrosion, they were only able to fulfil this task for a while (in their original position, 34 vertical frames ensured the strength of the structure of the bulkhead, while in the position turned

90° to the right, the whole weight was loaded on only 4 - originally horizontal - transversal stiffeners). However, the degradation of the hull first started (between 1915-1960) at those points where there were no watertight bulkheads built into the structure (that is, on the superstructure). In the second stage of structural damage (between the 1960s and 1980s), some side wall sections on the portside of the hull collapsed in between the bulkheads (e.g., in the turbine space, as evidenced by John Light's recordings), but the bulkheads remained standing, and they probably maintained this position until the tilting back of the double bottom of the ship occurred as described earlier. Since the resulting diagonal distortion of the hull (sometime at the turn of the 1980s and 1990s) is unthinkable without further severe damage to the bulkheads, which, by then had already suffered significant corrosion damage, their collapse can also be attributed to this period (as Robert Ballard confirmed this by the recordings of his 1993 expedition, according to which the tilting back of the ship's bottom and the accompanying collapse of the ship's hull had already occurred by then).

**Fig. 9:** The collapsed remains of the bulkhead between boiler room No. 1 and 2 (which are approx. 1,0-1.5 m high), viewed from boiler room No. 2 on the starboard side of the hull (photo by Stewart Andrews). The holes visible on the wall are damage caused by corrosion.

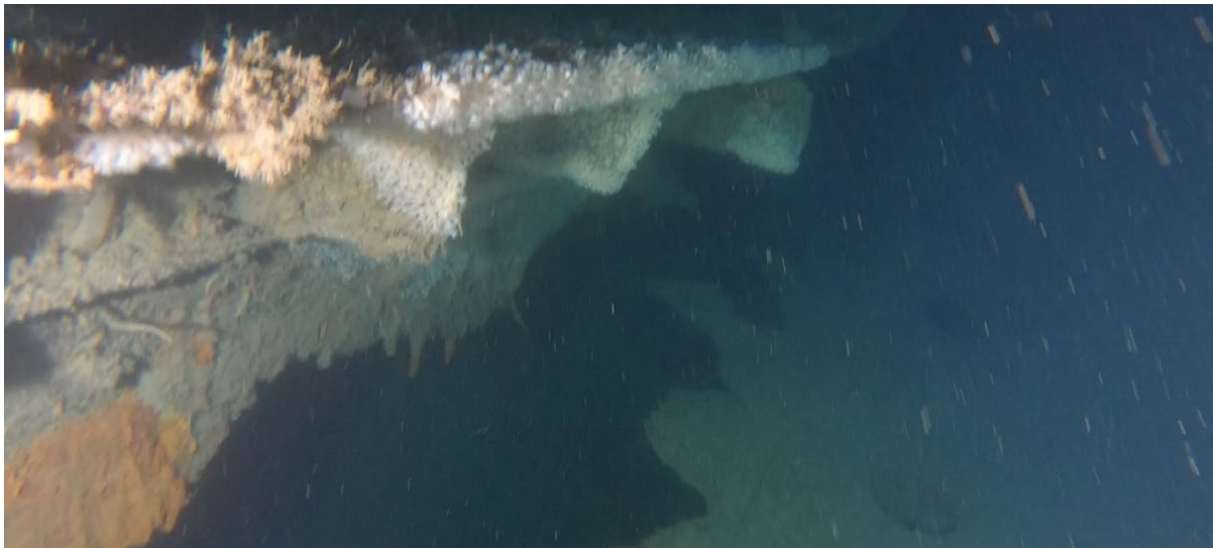
**On the portside of the hull (now on the top of the wreck), there is an increasingly widening fracture:** After the sinking, the ship was lying on her starboard side for a while and the bottom standing in a vertical position. Later the bottom tilted back to the plane corresponding to its original position, while the starboard side was broken off and remained in place, while the portside of the ship pulled by the tilting bottom along itself for a while, but the weakened side plates finally were torn apart along the upper edge of the double side. The plate edges separated along this rupture, moved away from each other both horizontally and vertically. The opening formed in this way is the largest above the area of boiler room No. 1, and narrows towards the bow.

**Fig. 10:** *Fracture on the hull. On the left, the plates that make up the underwater part of the ships port side, and on the right, the plates that make up the part above the water (shot by Stewart Andrews).*

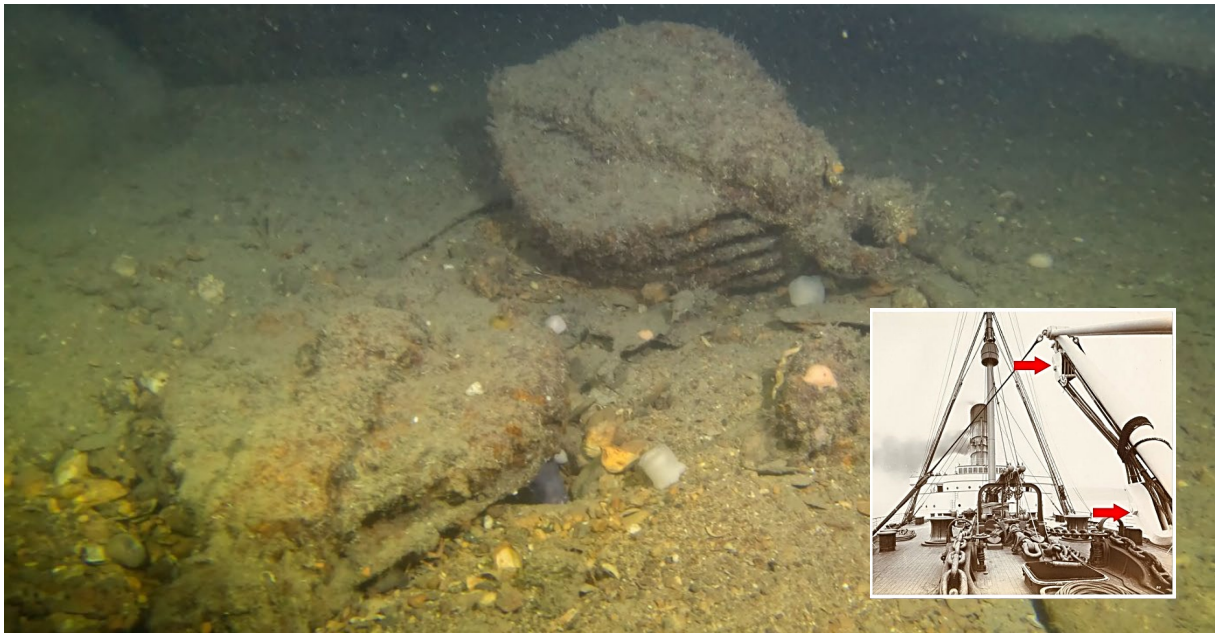
**Many small details can be recognized on the portside of the bow:** On the portside of the broken bow section - in the place of the removed main anchor - the rust deposit of the outline of the anchor can still be seen to this day. In the vicinity of the bow (on its starboard side), within a 10 m radius of the structure, two blocks are present, which were originally an accessory to the anchor crane on the bow deck. The section of the anchor chain that was still running freely on the bow part of the promenade deck was introduced in the chain pipe in front of the anchor winches into the chain locker located several decks deeper. As a result of corrosion, the chain (hawse) pipe has now disappeared, so a section of the anchor chain, leading to the winch on the promenade deck, can be seen one level down, at the level of the shelter deck. The section of the ship's side plates bearing the ship's name can be seen near the triple fairleads, which was originally on the edge of the bow deck, on the port side, just above that plate on which the last letter 'A' of the name LUSITANIA can be clearly read.

**Fig. 11.:** Blocks of the anchor crane found on the seafloor near to the starboard side of the bow (photo: Patrick Valkenborghs).

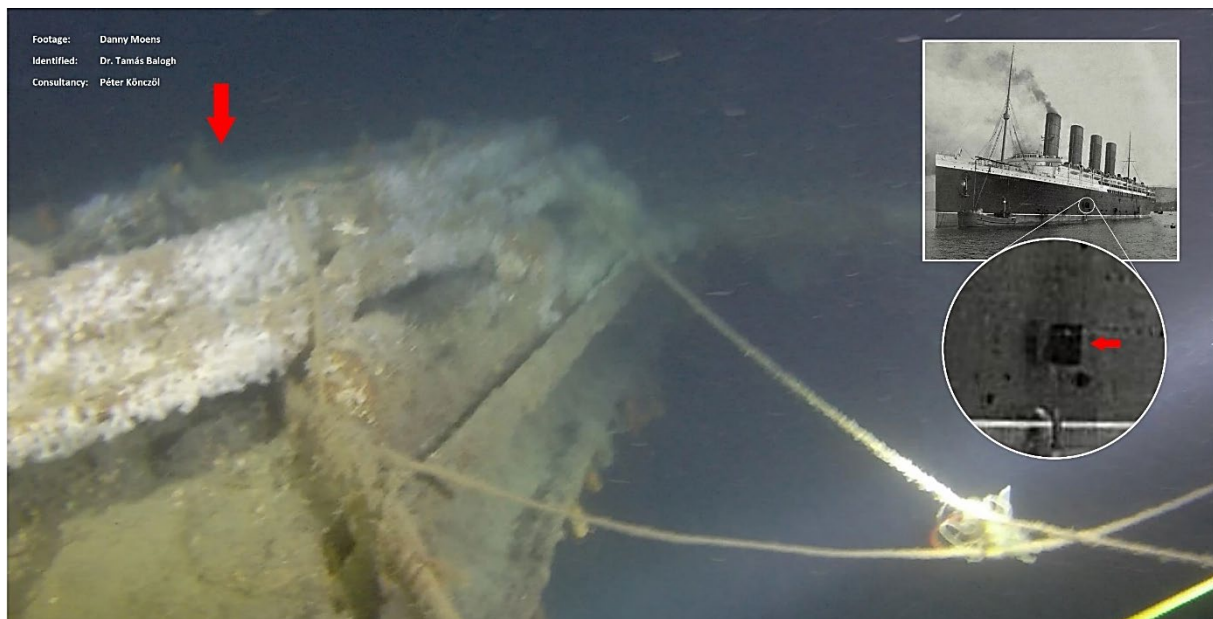
**Open doors accelerated the sinking not only under water, but also above it:** The divers identified the first two boarding doors on the portside plates of the bow section just in the line of the aft end of the boiler room № 1. Like those two doors identified by Robert D. Ballard in 1993 on the same deck but much further back, these two doors are also open. Since these doors could not be opened accidentally (their multiple securing prevented this), their open state clearly indicates that the crew opened them to facilitate the evacuation of passengers (trusting that through these doors would allow the passengers an easier way to enter the lifeboats which had been lowered from the boat deck in an empty state). Finally, the open doors were of no use in the rescue. However, the sinking of the ship was accelerated (similarly to the open coal-bunker doors in the boiler rooms), because as the water crossed the thresholds of these openings, it quickly started to flood the spaces above the ship's watertight deck, completely eliminating the ship's buoyancy.

**Fig. 13.:** *The forward door for passengers' boarding is open on the port side of the hull (photo by Danny Moens).*
