## **The Secret of LUSITANIA**

written by Dr. Tamás Balogh

**Between July 6-14, 2022, the wreckage of the British ocean liner LUSITANIA, sunk by a torpedo in 1915, was searched in the Atlantic Ocean. The expedition - carried out for the first time with the cooperation of Hungarian historical and technical experts - can put an end to 107 years of speculation.**

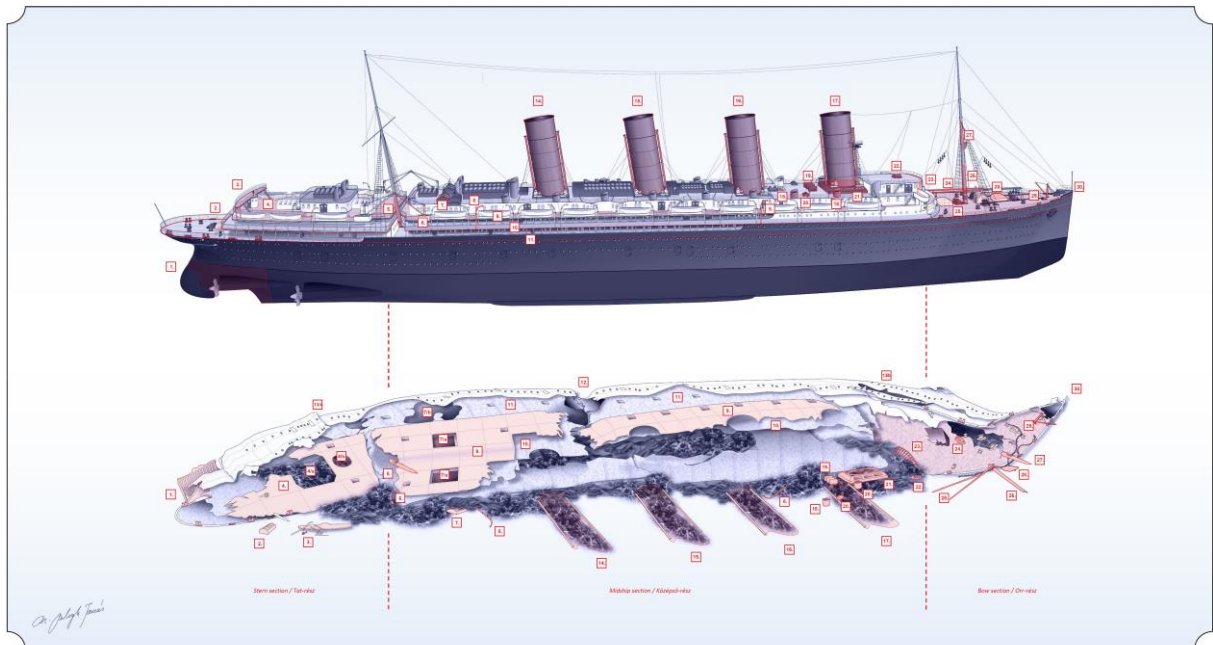
1. - Stern casing (separated from the stern section) / A farokszárny (a tartószárról különvált)
2. - Staircase over the hatch to the steering gear / A kormánygép szerkezetének lépcsője

3. - Decking bridge (with the follow engine telegraph) / A kövő motor (a kövő gépponttal)
4. - Boat deck of the 2<sup>nd</sup> class superstructure / A 2. osztályú felépítményének csúcsfedéllete

- 4/a - Opening for the 2<sup>nd</sup> class staircase on level of the boat deck / A 2. osztályú lépcsőház nyílása a csúcsfedélleten
- 4/b - Opening for the skylight of the 2<sup>nd</sup> class drawing room / A 2. osztályú iroda (háló-teremtől) felüljárója

5. - Stump of the main mast with cleats for halyards around its base / A főszárny csúcsja, az alágak körüli kötélpontokkal
6. - Arm out of the hoisting crane, with the pulley at its end / A kábel megemelőjének karja, végén a kötélponttal

7. - Skylight of the engine room hatch / A gépészeti csúcsfedélletének felüljárója
- 7/a - Opening of the hatch on the level of the boat- and the promenade deck / Az alágak nyílása a csúcs- és a sétajáraton

- 7/b - Portside opening of the hatch on the level of the shelter deck / A bal oldali alágak nyílása a védőfedélleten
8. - Lifboat davit / Mentőcsónak tartó

9. - Boat deck of the 1<sup>st</sup> class superstructure / A 1. osztályú felépítményének csúcsfedéllete
10. - Promenade deck of the 1<sup>st</sup> class superstructure / A 1. osztályú felépítményének sétajáratja

11. - Shelter deck of the 1<sup>st</sup> class superstructure / A 1. osztályú felépítményének védőfedéllete
12. - Break through the entire hull (formed during the sinking) / A teljes hajótestet átszövő törés (a süllyedéskor keletkezett)

- 12/a - Fracture of the stern section that broke off due to the lack of support (formed decades after the sinking) / Az asternszakasz teljes mértékben elszakadt a tartószárról (a süllyedés után keletkezett)

- 12/b - Fracture of the hull plates in the stern section, due to the decomposition of the ship (formed decades after the sinking) / Az asternszakasz lemezeinek elszakadása a hajótest többi részétől (a süllyedés után keletkezett)

13. - Funnel for the HP 1. boiler room / A 1. sz. kazánházhoz tartozó kémény
14. - Funnel for the HP 2. boiler room / A 2. sz. kazánházhoz tartozó kémény

15. - Funnel for the HP 3. boiler room / A 3. sz. kazánházhoz tartozó kémény
16. - Funnel for the HP 4. boiler room / A 4. sz. kazánházhoz tartozó kémény

17. - Funnel for the HP 5. boiler room / A 5. sz. kazánházhoz tartozó kémény
18. - Coal vents to the stokehold / Az „üszolyák” ventilátorok a kazánház felülről

19. - Masternon / Vitoratörő
20. - Skylight of A23 on water room / Az A23-as vízteremtől felüljárója
21. - Cover of light and air inside around the HP 5. funnel base / Fény- és légtérrel körülvett A23-as kéménybázis
22. - Skylight of the wheelhouse on the navigation bridge / A kormányzó felüljárója a parancsnoki hídon
23. - Front wall of the navigation bridge / A parancsnoki híd homlokfalja
24. - Mast / Csúcs
25. - Arms of cargo cranes on the foremast (two of four) / Az előbboc daruknak karjai (kettő a négyből)
26. - Stump of the foremast / Az előbboc csúcsja
27. - Fragment of the foremast with access to the crew's rest / Az előbboc töredéke az utasok számára valószínűleg
28. - Mast cover of HP 1. cargo hold / A 1. sz. rakodóhely felüljárója
29. - Anchor crane / Horgonydarú
30. - Tip of the bow / Az orrszárny

Pictures 6 and 7: Overview of the wreck of LUSITANIA based on the results of the 2022 expedition (made by Dr. Tamás Balogh).
