The Secret of LUSITANIA

written by Dr. Tamás Balogh

Between July 6-14, 2022, the wreckage of the British ocean liner LUSITANIA, sunk by a torpedo in 1915, was searched in the Atlantic Ocean. The expedition - carried out for the first time with the cooperation of Hungarian historical and technical experts - can put an end to 107 years of speculation.

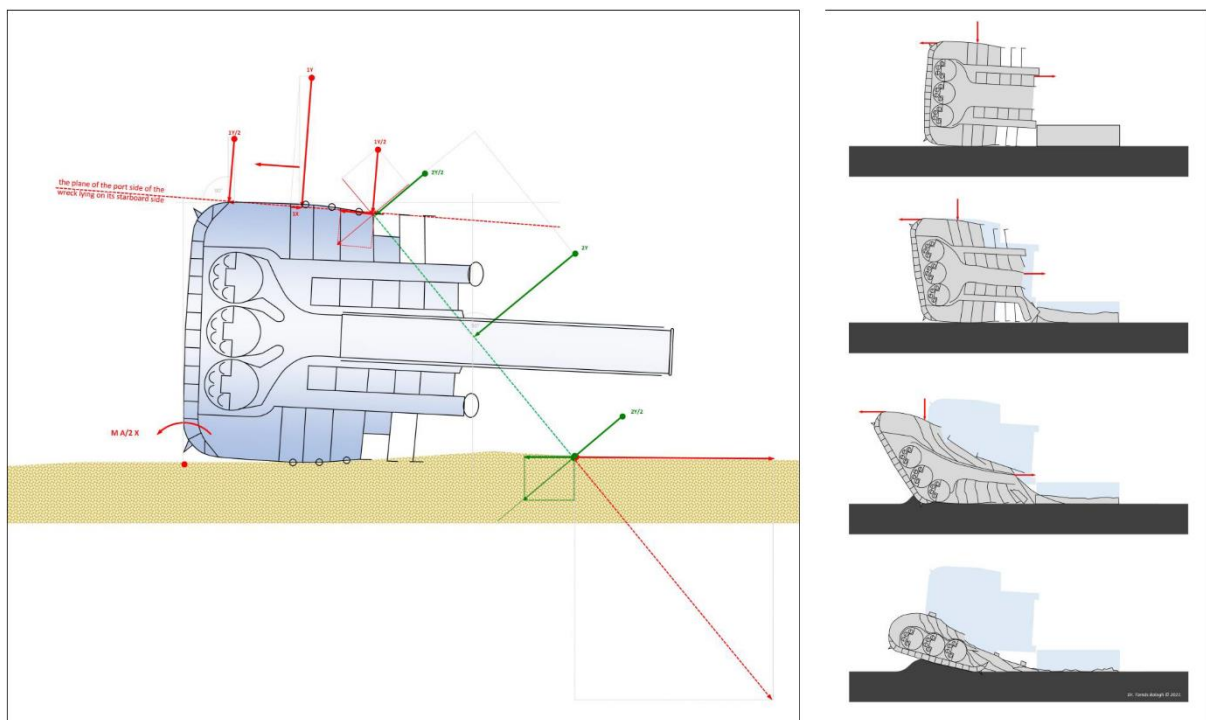
Pictures 4 and 5: The causes and process of the disintegration of LUSITANIA. Immediately after sinking, the ship capsized and laid on the seabed on its starboard side is affected by the forces indicated in red. Namely: 1) Nearly vertical pressure forces. 2) Near-horizontal pulling forces arising from the pressuer forces (due to deviation of the hull - lying on its side - from the vertical). 3) torque, arising from the pulling forces (and acting around the point where the double bottom standing on the seabed). The LUSITANIA was the first ocean liner in which a large amount of high-strength silicon steel was installed (so that hull, supported by two wave crests at both ends, hanging freely above the wave valley, could flexibly bear the internal tension arising from the huge bending moment). The portside, loaded with silicon steel plates installed in two layers in the upper part of the midship section, rose 26 m above the seabed when the ship turned to its starboard side after the sinking, and was not supported by any other, but deck beams, which installed between the side frames. However, they were not designed for this load, and therefore – as soon as the compressive force resulting from the weight of the double plating was transferred to the decks – they bent under the weight over time. Adding to the loss of strength due to corrosion, the process was accelerated. As the deck beams bent due to the weight of the port side, their length and thus the width of the hull decreased. But - because these beams were attached to the side frames supporting the side walls of the ship - bent deck beams started the downward movement of the port side, which generated an extremely high pulling force. This also had an effect on the structure of the ship's double bottom, which - as a result of the pressure from the port side, which is now pressing on it at an angle - began to tilt from its almost vertical position towards the seabed, (i.e. to the left), while the structures in the ship's hull moved in the opposite direction, obeying the weight of the downward moving port side. The decks gradually began to slide out to the right of the collapsing hull. As a result, the forces marked in green (compressive forces resulting from their weight acting on the decks that slid out of the hull in an inclined plane) occurred, which accelerated the process (their effect was added to the forces that started the movement of the structure to the left). The collapse of the wreck was already spectacular during the 1993 expedition led by Robert Ballard, but since then it has significantly increased. Even Ballard was shocked to find that the hull lying on its side - instead of rising 24-26 m above the seabed, as one might expect - was only 19 m high. However, the latest SONAR images taken in the 2000s confirmed that the height of the ship's hull is now only 13 m. The collapse of the ship's hull is accompanied by other deformations and distortions due to the forces acting on the structure as a whole. Today, not only is the wreck almost completely flattened, but its upper decks (belonging to the former superstructures) have also completely slipped out of the ship. The former structure is becoming less and less recognizable, and it is likely that it will soon completely collapse. (drawings made by: Dr. Tamás Balogh).

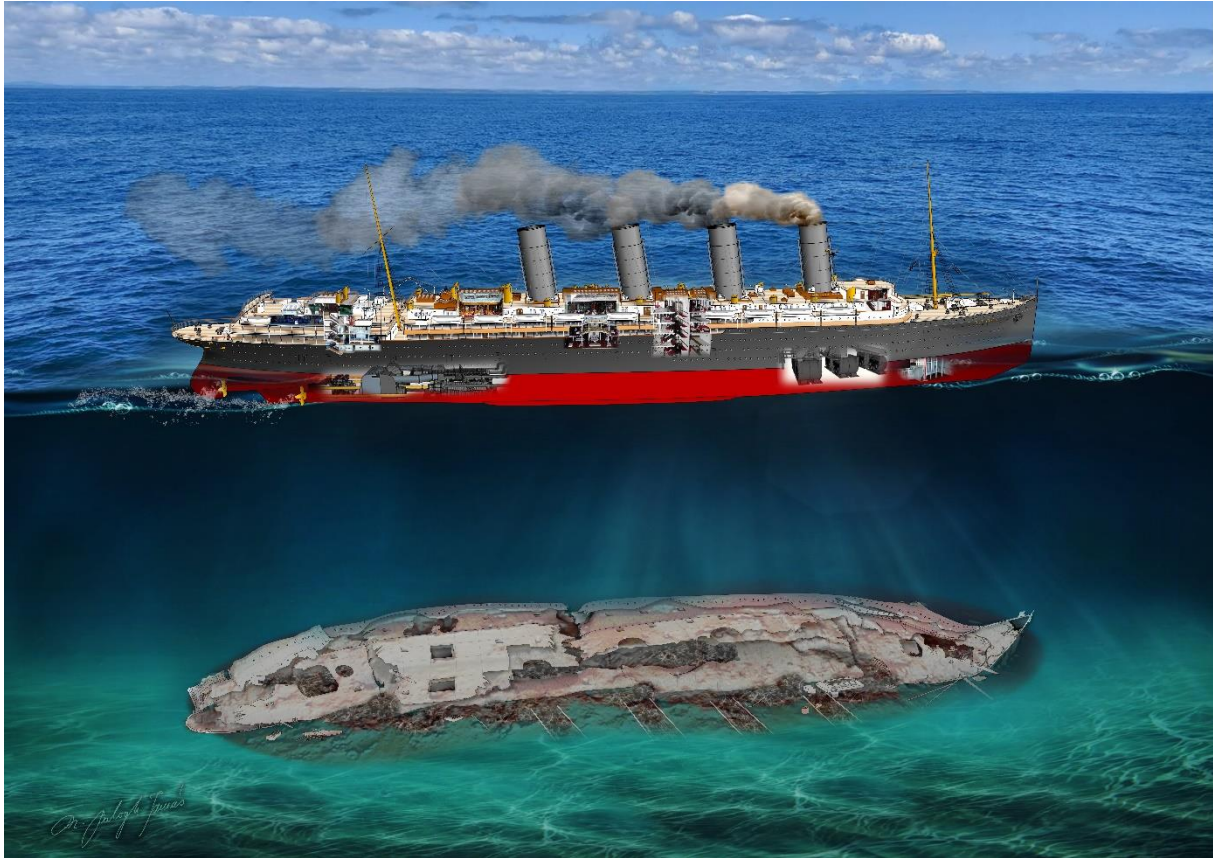
1. - Stern casing (separated from the stern section). / A farokszarv (a két részből különvált).
2. - Skylight over the hatch to the steering gear. / A kormánygépi szerkezet fölé nyíló fényvető.

11. - Shelter deck of the 2nd class superstructure. / A 2. osztályú felsőépítészeti csúszkafedélzet.
12. - Break through the entire hull (formed during the sinking). / A teljes hajótesten átszövedő lyuk (a süllyedéskor keletkezett).

- 12/a - Fracture of the stern section that broke off due to the lack of support (formed decades after the sinking). / A farokszarv törése a támasz hiánya miatt (keletkezett évtizedek múlása után).

- 12/b - Fracture of the hull plates in the stern section, due to the decomposition of the ship (formed decades after the sinking). / A farokszarv lemezeinek törése a hajó bomlása miatt (keletkezett évtizedek múlása után).

Pictures 6 and 7: Overview of the wreck of LUSITANIA based on the results of the 2022 expedition (made by Dr. Tamás Balogh).

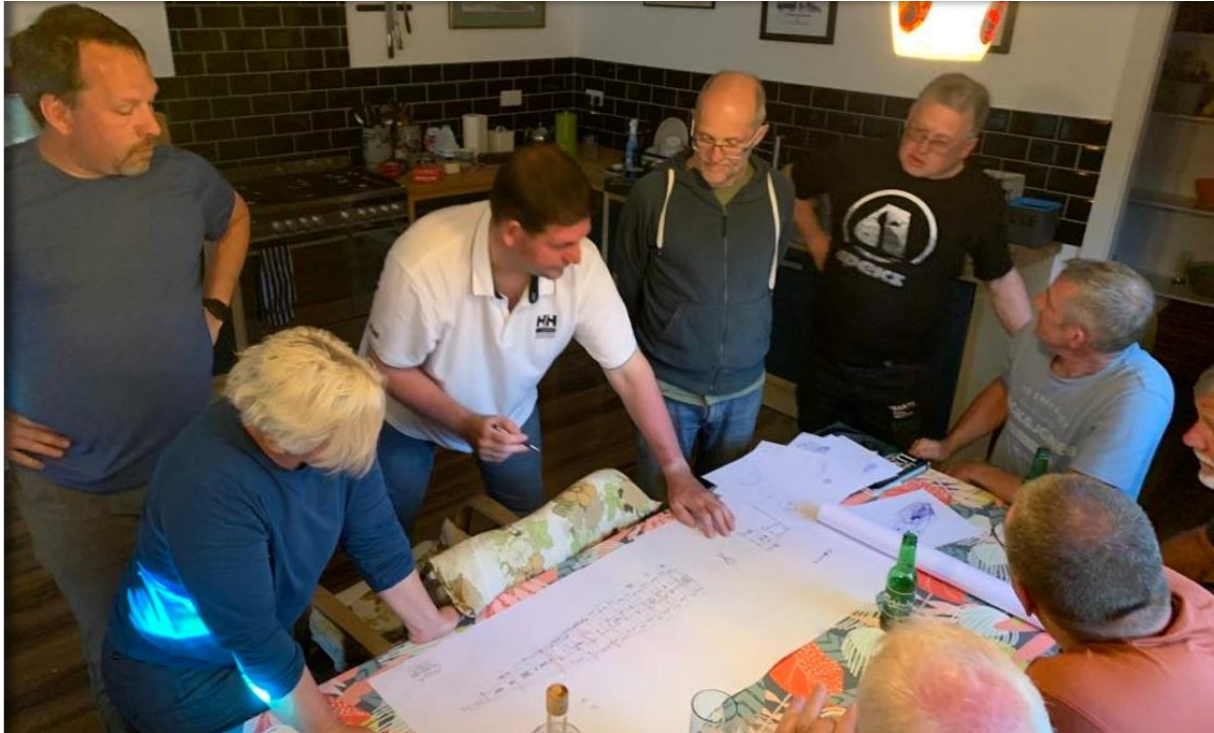
Pictures 8.: Team at work. Selection of the research area based on evaluation of the known information. (prepared by: Péter Könczöl).

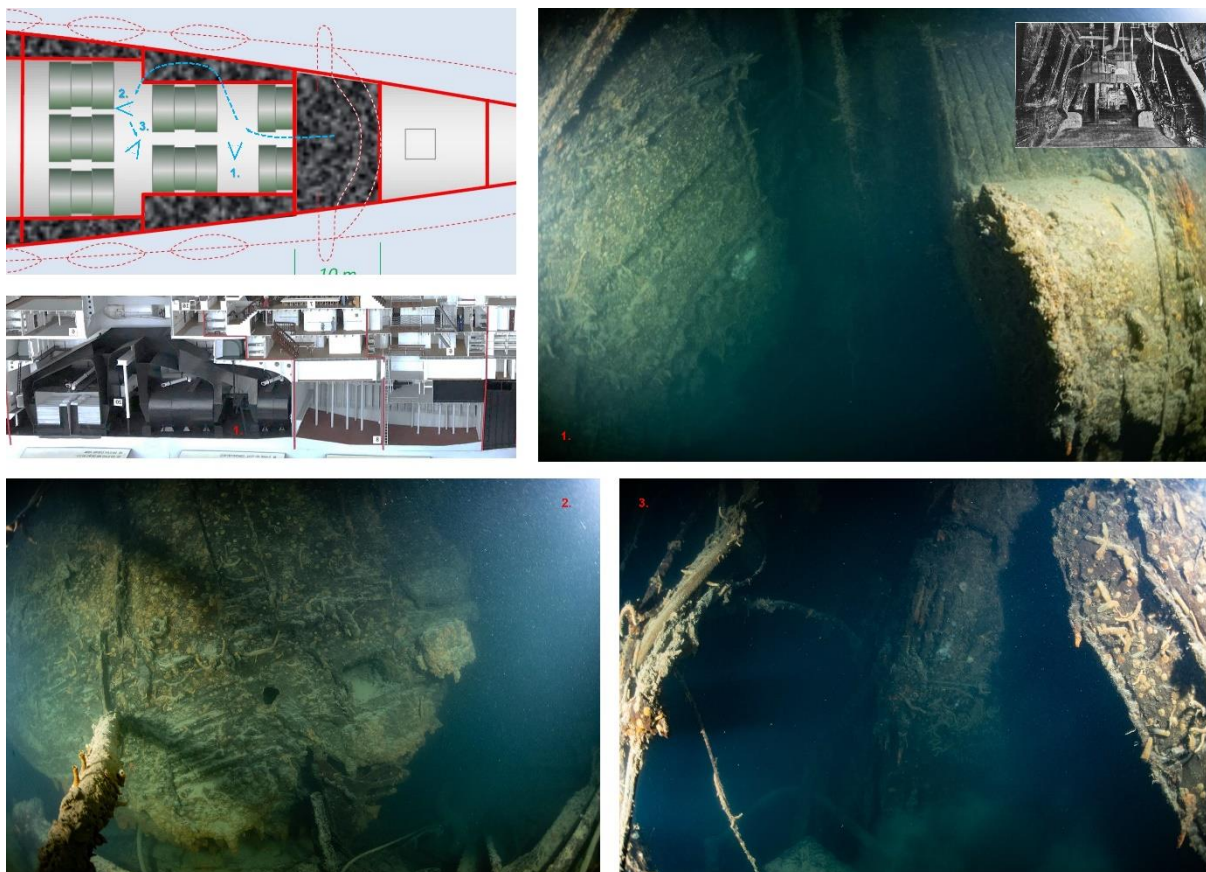
Pictures 11., 12, 13 and 14: Photographs taken in the forward boiler room of the *LUSITANIA* (by Darragh Norton) and a drawing to help identify where they were taken (by Dr. Tamás Balogh).

- 1) 5 of the 7 boilers in the boiler room are visible to some extent (both single-ended boilers of the first row, the left double-ended boiler of the middle row and the middle and left boilers of the third row).

- 2) Out of the 5 boilers seen, 3 must have moved from their original base and – looking towards the bow of the ship – jumped out of its original seat to the right of it (into the free space situated between their supports and supports of the adjacent boilers to its right).

- 3) The condition of 3 of the 5 boilers seen is known: 2 are intact, 1 shows damage (the cause of the damage - whether related to the sinking or the collapse of the wreck -, as well as the exact extent and circumstances of its origin will be determined by the currently ongoing investigation).

- 4) Around the bases of the boilers (in the former stokeholds) remains of the stokehold plates can be seen (on which the trimmers stood and walked during their work) and the row of thin columns supporting them.

- 5) However, further debris from the remains of other equipment of the boiler rooms (exhaust- and funnel uptakes, or assembly walkways and ladders, etc.) cannot be identified (just the remainings of the ash ejectors can be seen, directly attached to the boilers). The probable reason for this is that the wreck lay on its starboard side on the seabed for an unknown period of time, but later (sometime between the early to mid-1970s and mid-to-late 1980s) the double bottom of the hull tilted to the left side (looking towards to the bow), i.e. tilted back almost to its original horizontal position, dragging the left side of the hull with it. This means that for a relatively long time (50-60 years), the boiler houses were turned (hanging) about 90 degrees to the right compared to their original position. The resulting load could only be bore by the strongest structural and material connections, but the corrosion of the weaker joints and thinner materials took place in this turned position, so everything that loosened or broke during this period fell down to the starboard side inside the hull.

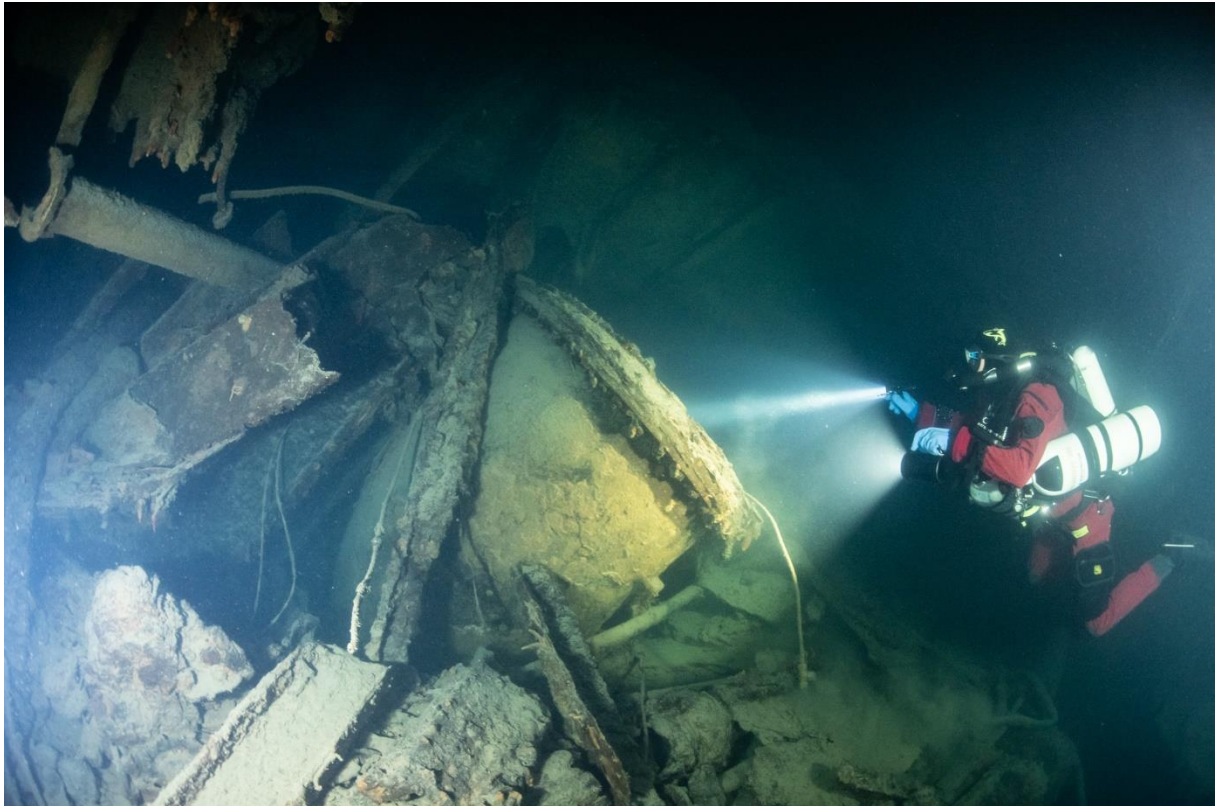
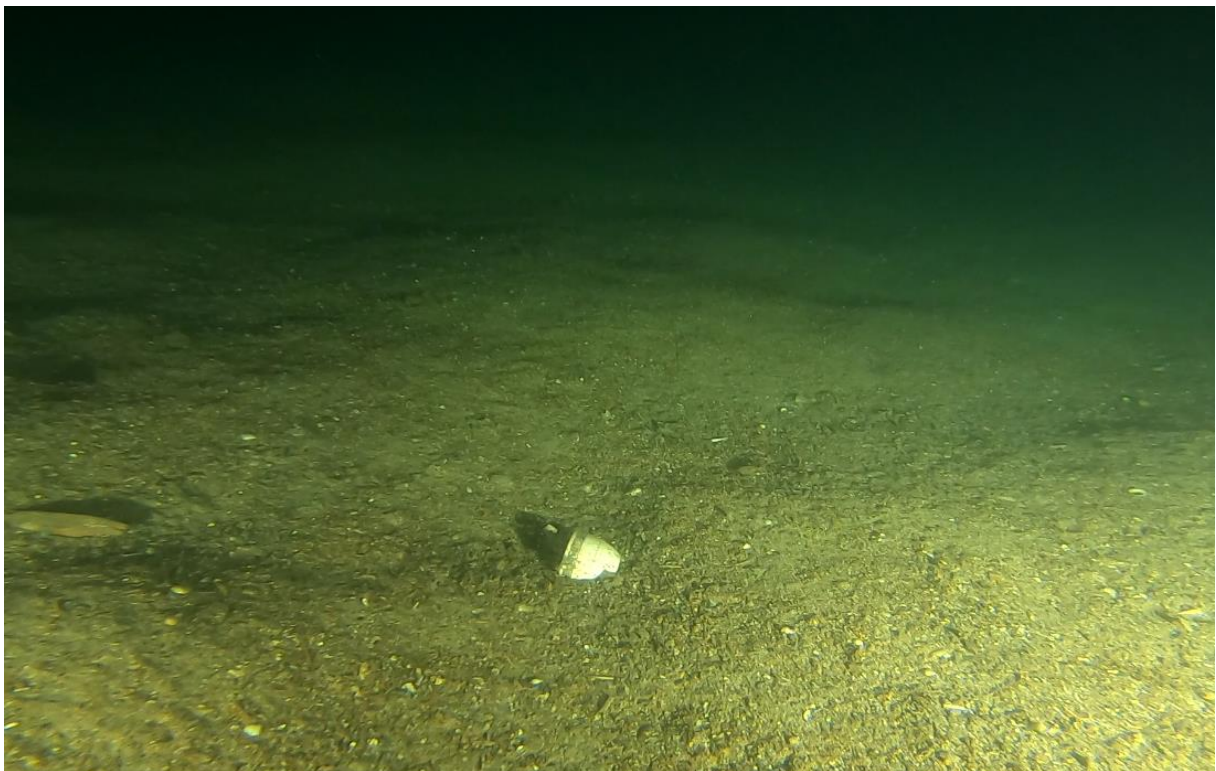
However, the research focused not only on the bow section of the ship, but also enriched the exploration of the stern section with additional results: The divers - with the exception of a 40 m long portion of the midship section - essentially researched the entire length of the shipwreck, and among other things, they were able to enter into the engine room, where they identified the remains of one of the steam turbines and the condenser.

Pictures 15 and 16: From the largest to the smallest - pieces of the wreck. Above: Michael Walz in the port engine room of LUSITANIA. Below: a coffee cup in the mud. (by Darragh Norton).

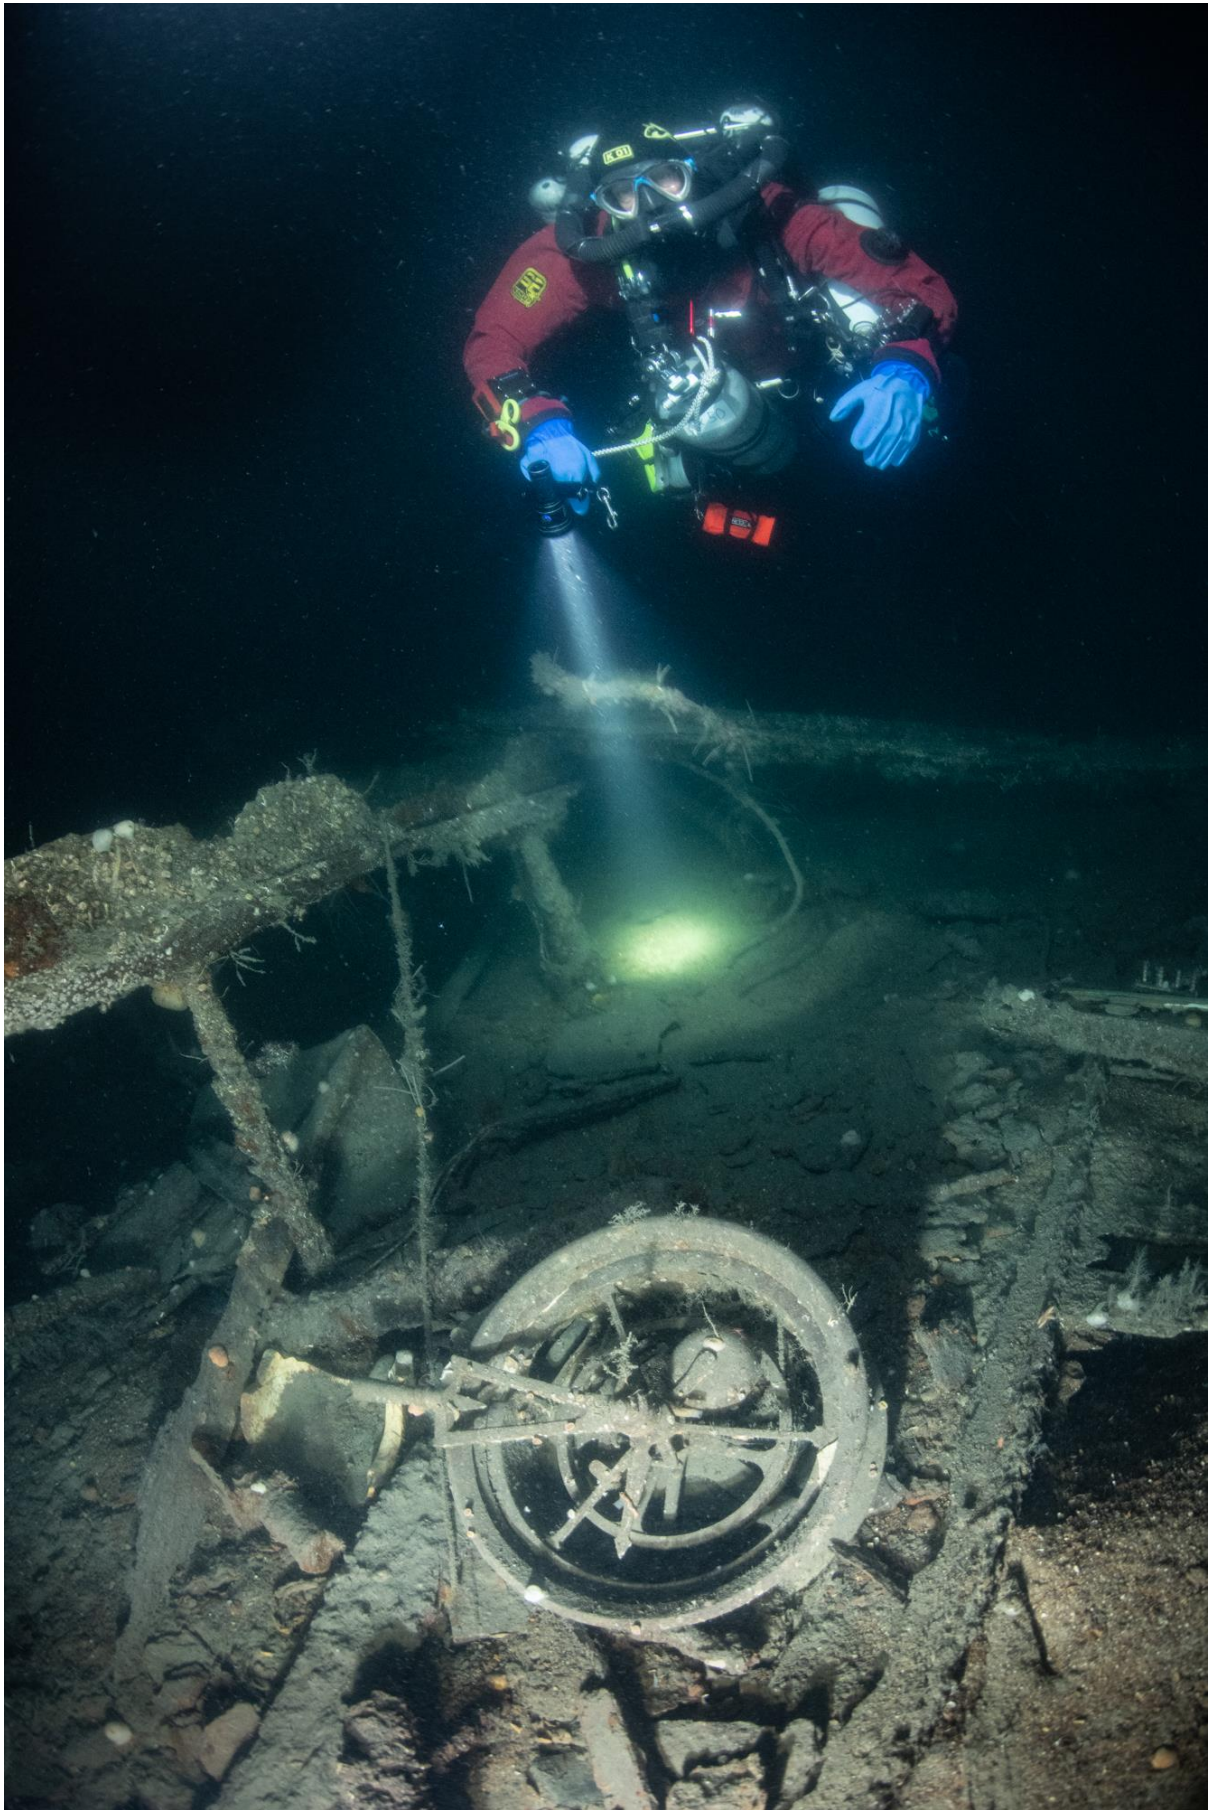
Photo 17: *Remains of LUSITANIA's engine telegraph near the docking bridge (by Darragh Norton).*

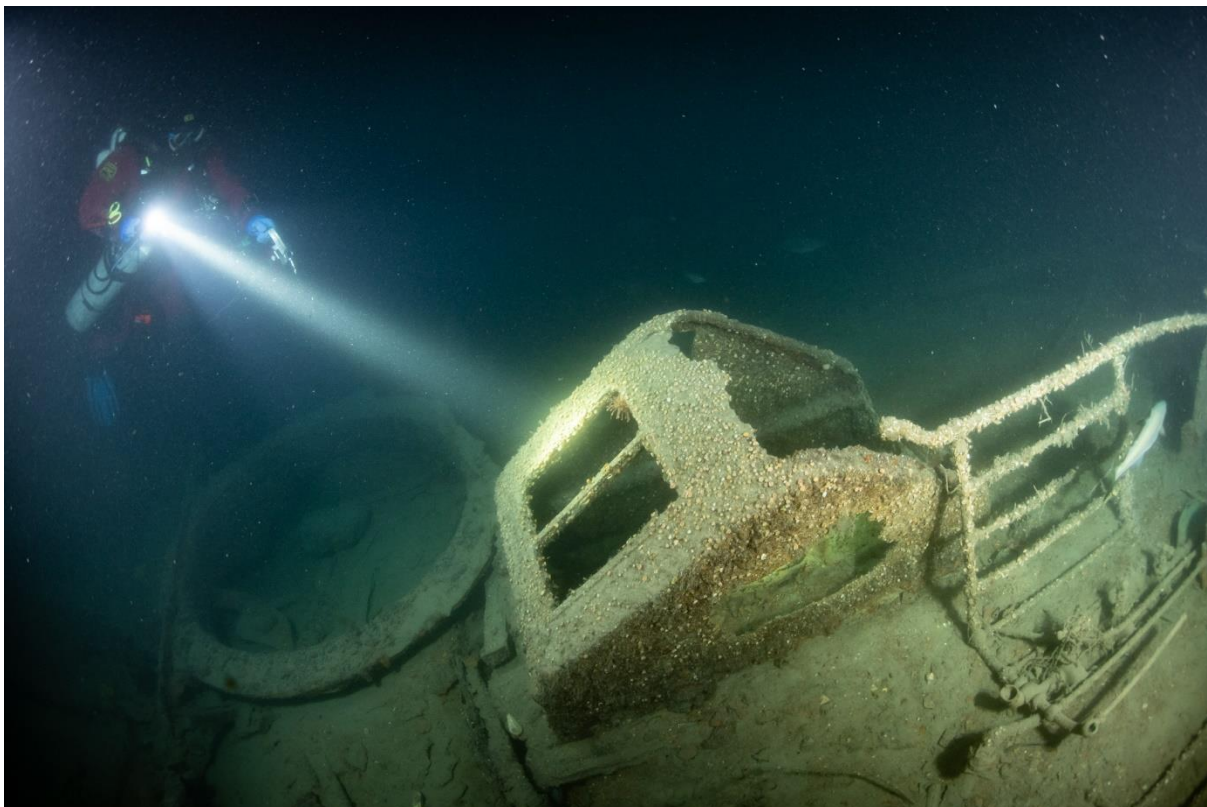
Image 18: *Skylight of en suite room A23 and holder of the shower curtain from the bath (by Darragh Norton).*

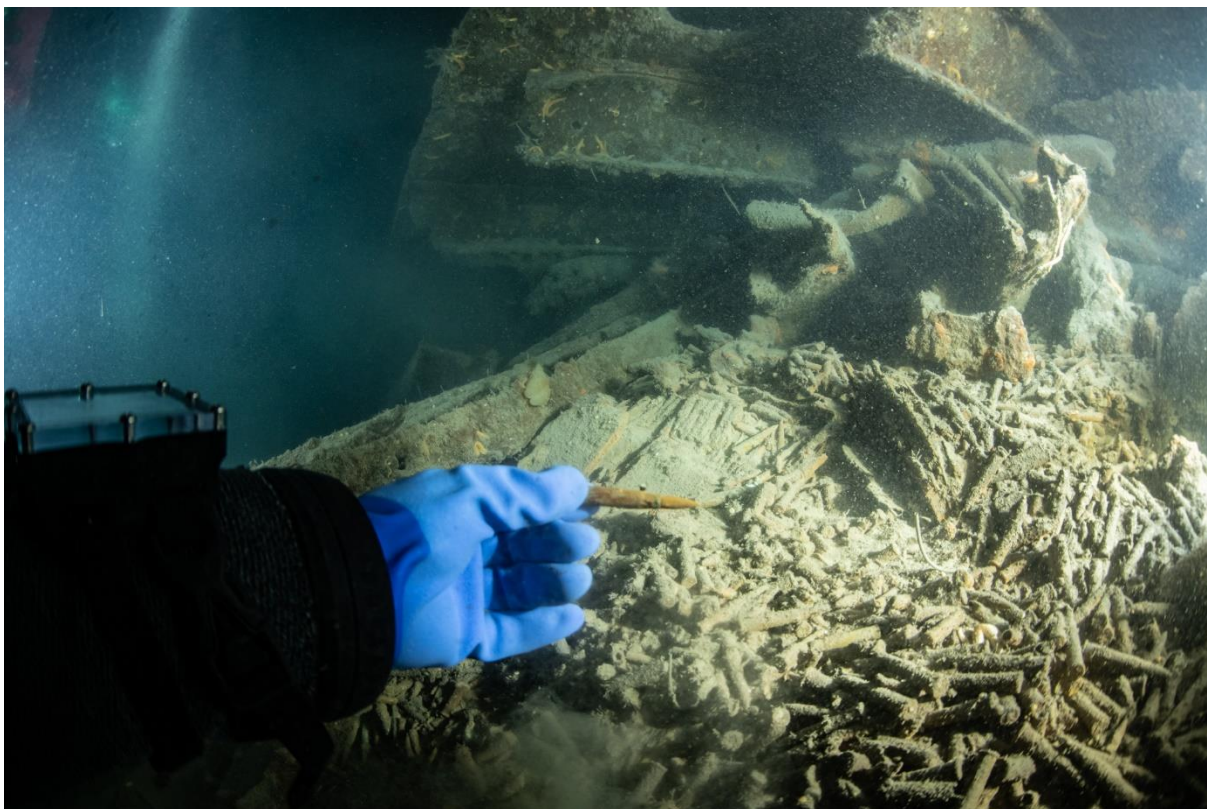
Photo 19: *A large amount of scattered small arms ammunition in the forward cargo hold of the LUSITANIA (by Darragh Norton).*
