## **The Secret of LUSITANIA**

written by Dr. Tamás Balogh

**Between July 6-14, 2022, the wreckage of the British ocean liner LUSITANIA, sunk by a torpedo in 1915, was searched in the Atlantic Ocean. The expedition - carried out for the first time with the cooperation of Hungarian historical and technical experts - can put an end to 107 years of speculation.**

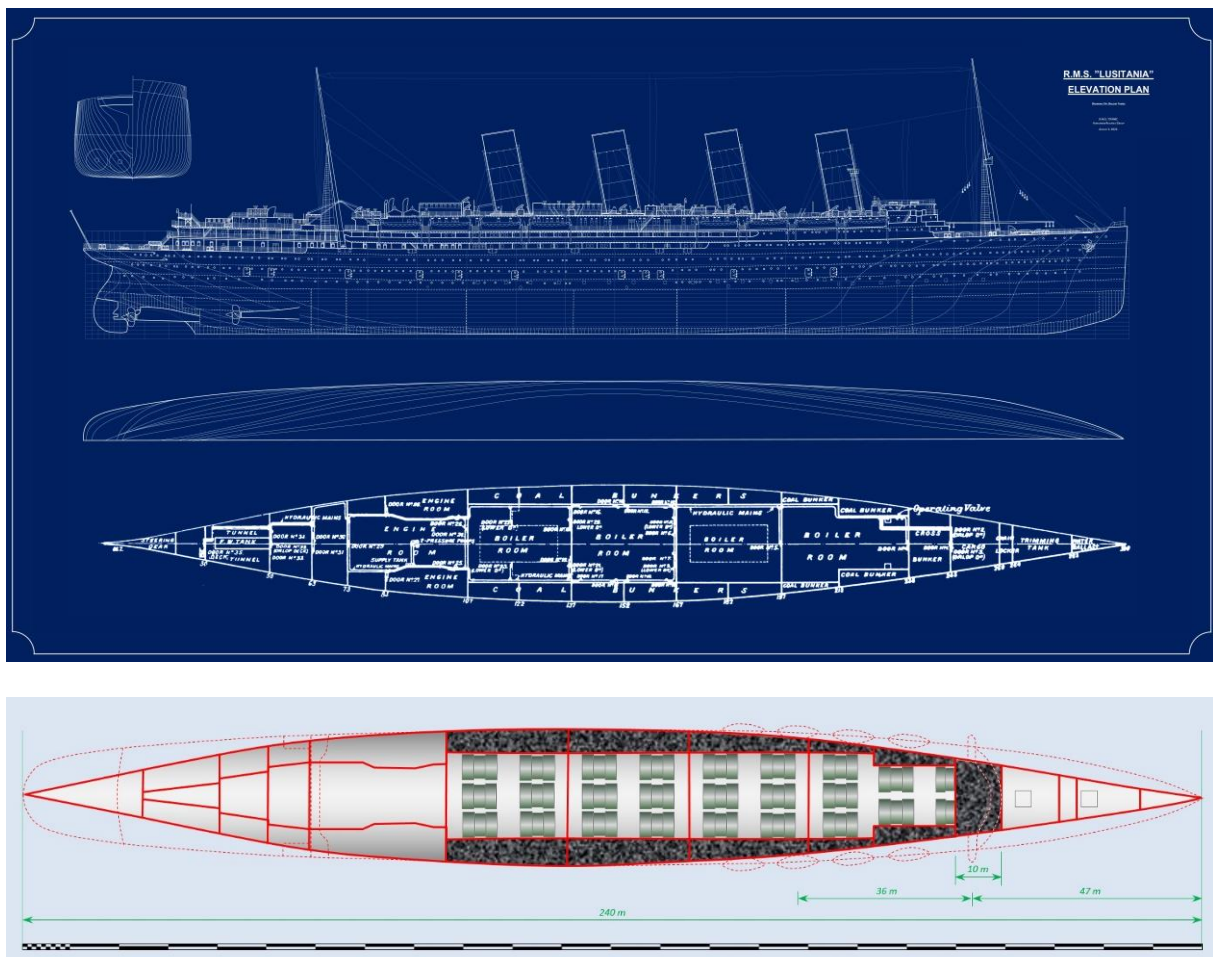
**Pictures 2 and 3:** General arrangement plan of the LUSITANIA (above) and its boiler rooms (below) (made by Dr. Tamás Balogh).

In the time since the tragedy, a total of 14 wreck-research expeditions have taken place, most of which added something to the history of the research: In 1935, Jim Jarret identified the wreck's position. Between 1960/63, John Light identified that the ship was lying on its starboard side and had broken in two. In 1982, the team of Oceaneering International Inc. confirmed that the ship was transporting ammunition and 3 propellers were brought to the surface. In 1993, the continuous deterioration of the wreck was confirmed and its final collapse was predicted by Robert D. Ballard. In 1995, the wreck was declared protected. In 2007, salvage was allowed. In 2008, the team led by Eoin McGarry discovered that there was far more munitions in the wreckage than the amount previously assumed. In 2011, one of the engine telegraphs and a 1st class cabin window were brought to the surface by an expedition initiated by Gregg Bemis. The 3D visualization of the wrecks began in 2017 and continued in 2019 and 2020 by the teams of Peter McCamley. And the 2022 expedition led by Darragh Norton succeeded for the very first time in conducting an internal inspection of the first boiler room, which is of outstanding importance from the point of view of the second explosion after the torpedo hit, refuting the popular belief since 2011 that the explosion of the first two single-ended boilers in the boiler room - aft from the bulkhead between the No. 1. boiler room and the No. 2. cargo hold (used sometimes as a reserve coal bunker) - accelerated the sinking of LUSITANIA.

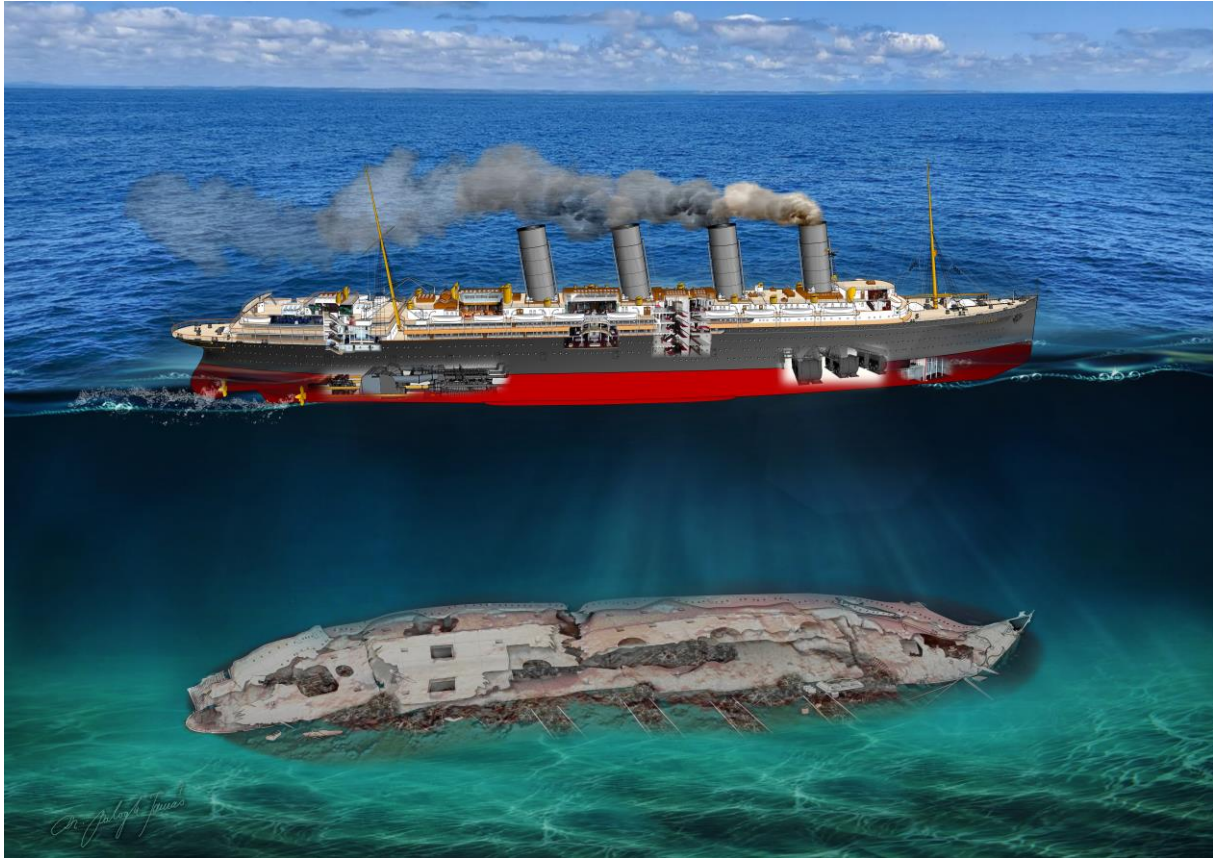
Pictures 6 and 7: Overview of the wreck of LUSITANIA based on the results of the 2022 expedition (made by Dr. Tamás Balogh).

1. - Stern casing (separated from the stern section) / A faroktest elszakadt részlete.
2. - Staircase over the hatch to the steering gear / A kormánygép szellőztetőjének lépcsője.

3. - Decking bridge (with the boiler engine telegraph) / A kazán fedélzetén lévő parancsnoki híradó.
4. - Boat deck of the 2<sup>nd</sup> class superstructure / A 2. osztályú fedélzetének szellőztetője.

- 4/a - Opening for the 2<sup>nd</sup> class staircase on level of the boat deck / A 2. osztályú lépcsőház nyílása a csónakfedélzeten.
- 4/b - Opening for the skylight of the 2<sup>nd</sup> class drawing room / A 2. osztályú átrium (rajongóterem) szellőztetője.

5. - Stump of the main mast with clews for halyards around its base / A főoszlop csomóján, az oszlop körüli kötélpárhuzalok.
6. - Arm of the hoisting crane, with the pulley at its end / A felvonó szerkezetének karja, végén a kötélpárhuzal csomója.

7. - Skylight of the engine room hatch / A gépészeti szellőztetőjének szellőztetője.
- 7/a - Opening of the hatch on the level of the boat- and the promenade deck / Az átrium nyílása a csónak- és a sétajelöltőn.

- 7/b - Portside opening of the hatch on the level of the shelter deck / A bal oldali átrium nyílása a védőfedélzeten.
8. - Lifboat davit / Mentőcsónak tartó.

9. - Boat deck of the 1<sup>st</sup> class superstructure / A 1. osztályú fedélzetének szellőztetője.
10. - Promenade deck of the 1<sup>st</sup> class superstructure / A 1. osztályú átriumjának szellőztetője.

11. - Shelter deck of the 1<sup>st</sup> class superstructure / A 1. osztályú fedélzetének védőfedélzete.
12. - Break through the entire hull (formed during the sinking) / A teljes hajótestet átszelő repedés (a süllyedéskor keletkezett).

- 12/a - Fracture of the stern section that broke off due to the lack of support (formed decades after the sinking) / Az átriumtest hátrévi részének elszakadása az oszlop hiánya miatt (képződött a süllyedés után évtizedekkel később).

- 12/b - Fracture of the hull plates in the stern section, due to the decomposition of the ship (formed decades after the sinking) / Az oszlop elszakadása miatt keletkezett repedés (képződött a süllyedés után évtizedekkel később).

13. - Funnel for the HP 1. boiler room / A 1. sz. kazánházhoz tartozó kémény.
14. - Funnel for the HP 2. boiler room / A 2. sz. kazánházhoz tartozó kémény.

15. - Funnel for the HP 3. boiler room / A 3. sz. kazánházhoz tartozó kémény.
16. - Funnel for the HP 4. boiler room / A 4. sz. kazánházhoz tartozó kémény.

17. - Funnel for the HP 5. boiler room / A 5. sz. kazánházhoz tartozó kémény.
18. - Coal vents to the stokehold / Az „üszályok” ventilátorok a kazánház fölött.

19. - Masthead / Tűztorony.
20. - Skylight of A23 on suite room / Az A23-as kabinok szellőztetője.
21. - Cover of light and air intake around the HP 5. funnel base / Fény- és levegőbeviteli burkolat az 5. sz. kéménynek a bázisánál.
22. - Skylight of the warehouse on the navigation bridge / A raktározási fedélzetének a parancsnoki híradón.
23. - Front wall of the navigation bridge / A parancsnoki híradó homlokfalja.
24. - Mast / Csúsz.
25. - Arms of cargo cranes on the foremast (two of four) / Az előboc daruknak karjai (kettő a négyből).
26. - Stump of the foremast / Az előboc csomója.
27. - Fragment of the foremast with access to the crew's rest / Az előboc töredéke az utasok számára valószínűleg kényelmesen.
28. - Hatch cover of HP 1. boiler hold / A 1. sz. kazánház fedélje.
29. - Anchor crane / Horgonydarú.
30. - Tip of the bow / Az orrszár.

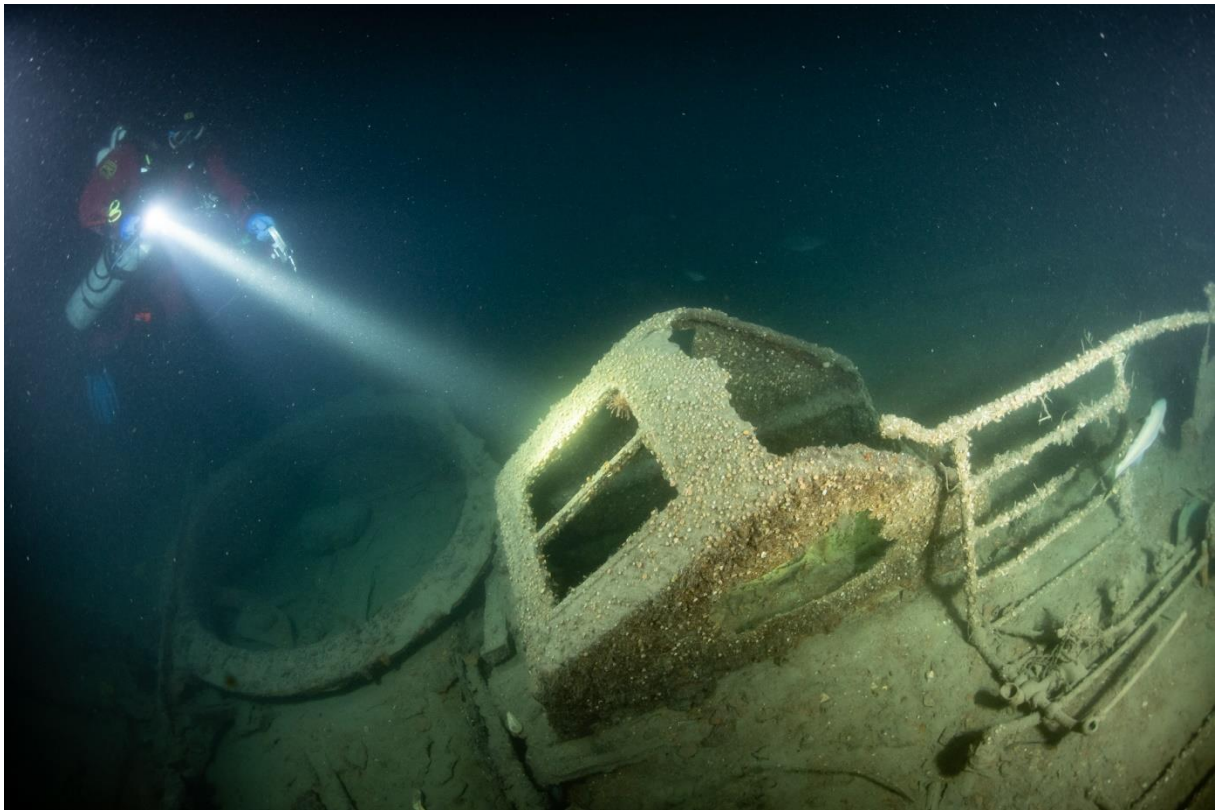
**Image 18:** *Skylight of en suite room A23 and holder of the shower curtain from the bath (by Darragh Norton).*
