## **The Secret of LUSITANIA**

**Between July 6-14, 2022, the wreckage of the British ocean liner LUSITANIA, sunk by a torpedo in 1915, was searched in the Atlantic Ocean. The expedition - carried out for the first time with the cooperation of Hungarian historical and technical experts - can put an end to 107 years of speculation.**

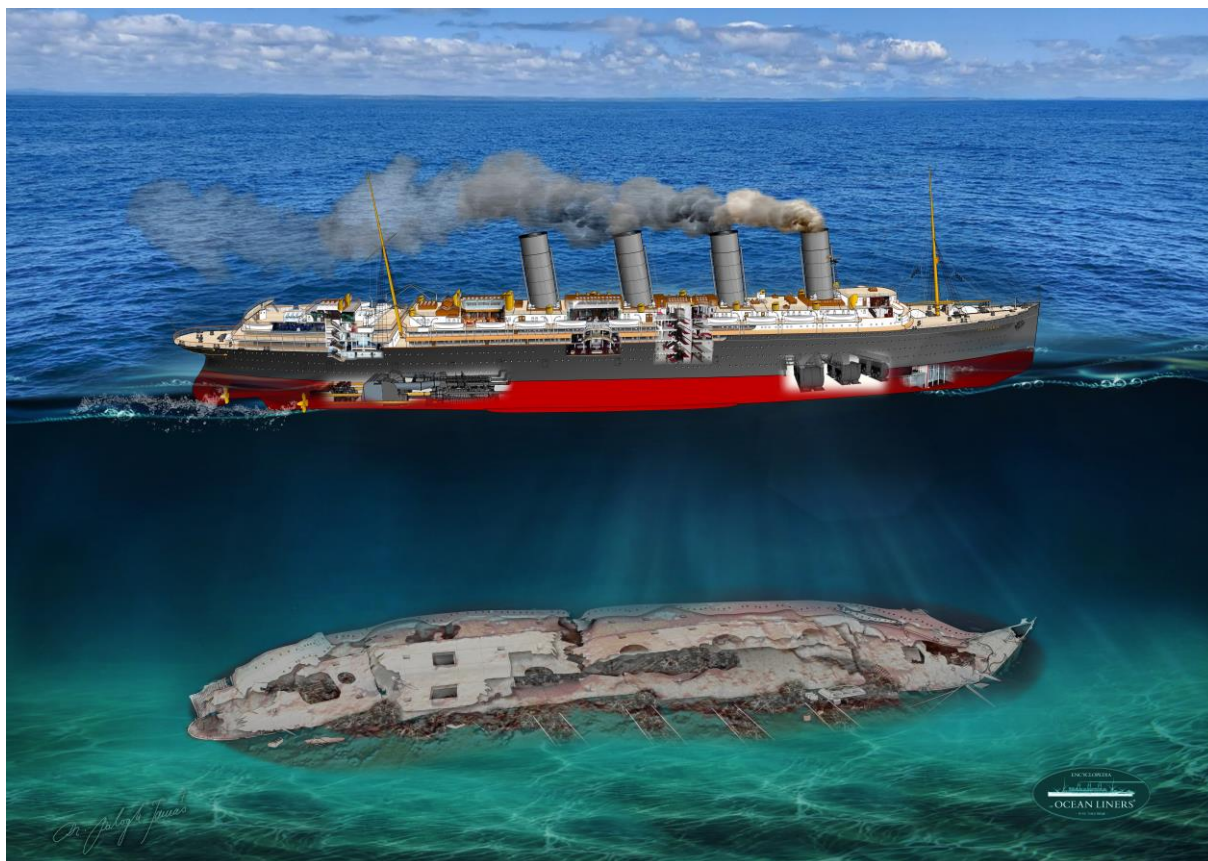
Pictures 6 and 7: Overview of the wreck of LUSITANIA based on the results of the 2022 expedition (made by Dr. Tamás Balogh).

1. - Stern casing (separated from the stern section) / A farokfal antenyája (a két részből különvált).
2. - Skylight over the hatch to the steering gear / A kormánygépi szerkezet fölé nyíló fénykinyílás.

3. - Decking bridge (with the boiler engine telegraph) / A kábel híd (a kábel vezérlővel).
4. - Boat deck of the 2<sup>nd</sup> class superstructure / A 2. osztályú felépítmények csúcsfedélzetén.  
4/a - Opening for the 2<sup>nd</sup> class staircase on level of the boat deck / A 2. osztályú lépcsőház nyílása a csúcsfedélzetén.  
4/b - Opening for the skylight of the 2<sup>nd</sup> class drawing room / A 2. osztályú ábrándó (háló) terem fénykinyílása.

5. - Stump of the main mast with clars for heliograph around its base / A fő árbóc csúcsja, az aljára körül állított heliógráfok.
6. - Arm one of the hoisting cranes, with the pulley at its end / A kábel emelőgép első karja, végére a kötélpáncél csigája.

7. - Skylight of the engine room hatch / A gépészeti szerkezet fölé nyíló fénykinyílás.  
7/a - Opening of the hatch on the level of the boat- and the promenade deck / Az első nyílás a csúcs- és a sétáldélen.  
7/b - Portside opening of the hatch on the level of the shelter deck / A bal oldali akna nyílása a védőfedélzet szintjén.

8. - Lifboat davit / Mentőcsónak tartó.

9. - Boat deck of the 2<sup>nd</sup> class superstructure / A 2. osztályú felépítmények csúcsfedélzetén.
10. - Promenade deck of the 1<sup>st</sup> class superstructure / A 1. osztályú felépítmények sétáldélen.

11. - Shelter deck of the 1<sup>st</sup> class superstructure / A 1. osztályú felépítmények védőfedélzetén.
12. - Break through the entire hull (formed during the sinking) / A teljes hajótestet átszelő törés (a süllyedéskor keletkezett).

- 12/a - Fracture of the stern section that broke off due to the lack of support (formed decades after the sinking) / Az állomántrész hátrései miatt leszakadt törés törés (keletkezett az elsüllyedés évtizedek múlta kő).

- 12/b - Fracture of the hull plates in the stern section, due to the decomposition of the ship (formed decades after the sinking) / Az orr-rész hullafalán lemezek a hajó szétbomlása miatt megrongált törés (keletkezett az elsüllyedés évtizedek múlta kő).

14. - Funnel for the HP 4. boiler room / A 4. sz. kazánházhoz tartozó kémény.
15. - Funnel for the HP 2. boiler room / A 2. sz. kazánházhoz tartozó kémény.

16. - Funnel for the HP 3. boiler room / A 3. sz. kazánházhoz tartozó kémény.
17. - Funnel for the HP 1. boiler room / A 1. sz. kazánházhoz tartozó kémény.

18. - Coal vents to the stokehold / Az „üvelykák” ventilátorai a kazánház fölöttételek.

19. - Water tanks / Vízteráriumok.
20. - Skylight of A23 on suite rooms / Az A23-as kabinok fénykinyílása.
21. - Cover of light and air intake around the HP 1. funnel hatch / Fény- és légtérnyílás körülbelül az 1. sz. kazánházra kábel.
22. - Skylight of the wheelhouse on the navigation bridge / A kormányzóterem fénykinyílása a parancsnoki hídon.
23. - Front wall of the navigation bridge / A parancsnoki híd homlokfalán.
24. - Mast / Csúcs.
25. - Arms of cargo cranes on the foremast (two of four) / Az első árbóc karjai (kettő a négyből).
26. - Stump of the foremast / Az első árbóc csúcsja.
27. - Fragment of the foremast with access to the crew's nest / Az első árbóc töredéke az állomány számára vezető lépcsővel.
28. - Hatch cover of HP 1. cargo hold / A 1. sz. rakodóhely fedélje.
29. - Anchor crane / Horgonydarú.
30. - Tip of the bow / Az orrszék.

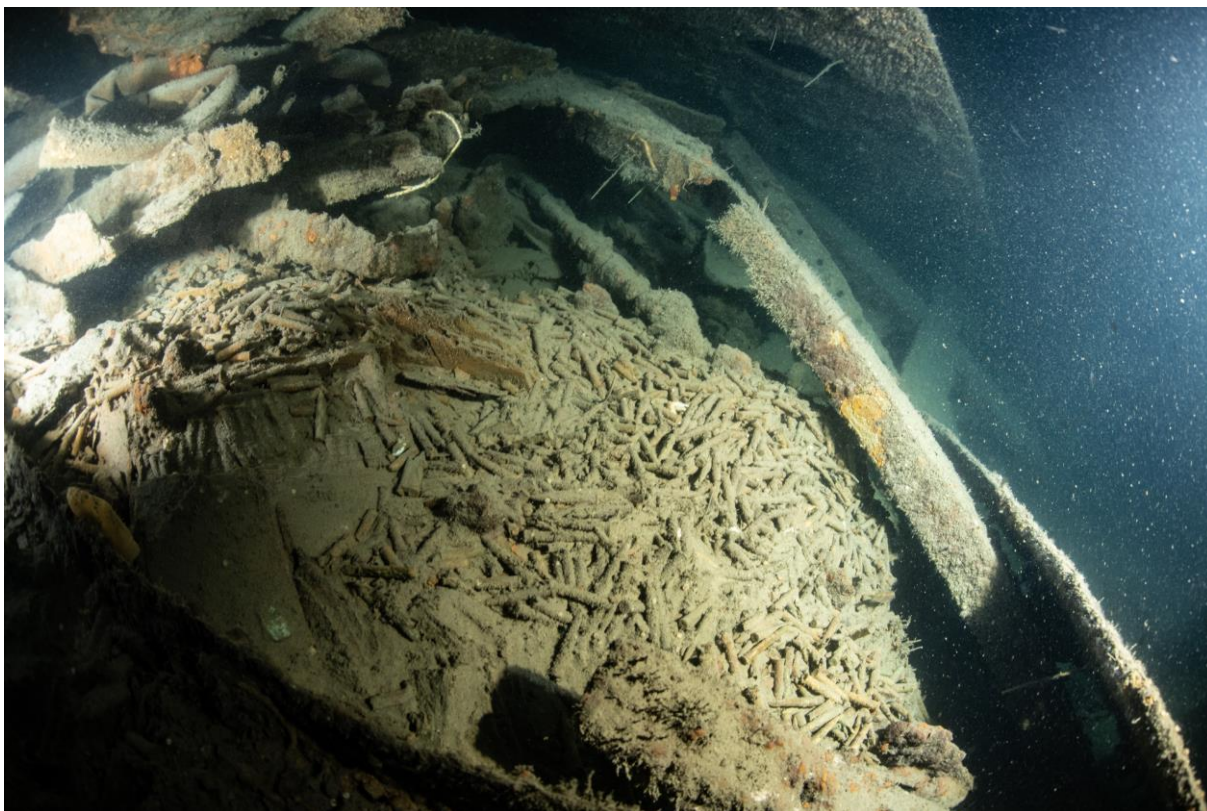
**Photo 19:** *A large amount of scattered small arms ammunition in the forward cargo hold of the LUSITANIA (by Darragh Norton).*
