## Newest results of LUSITANIA research

Dr. Tamás Balogh, Péter Könczöl

### What the shipwreck tells about - the results of the 2023 expedition

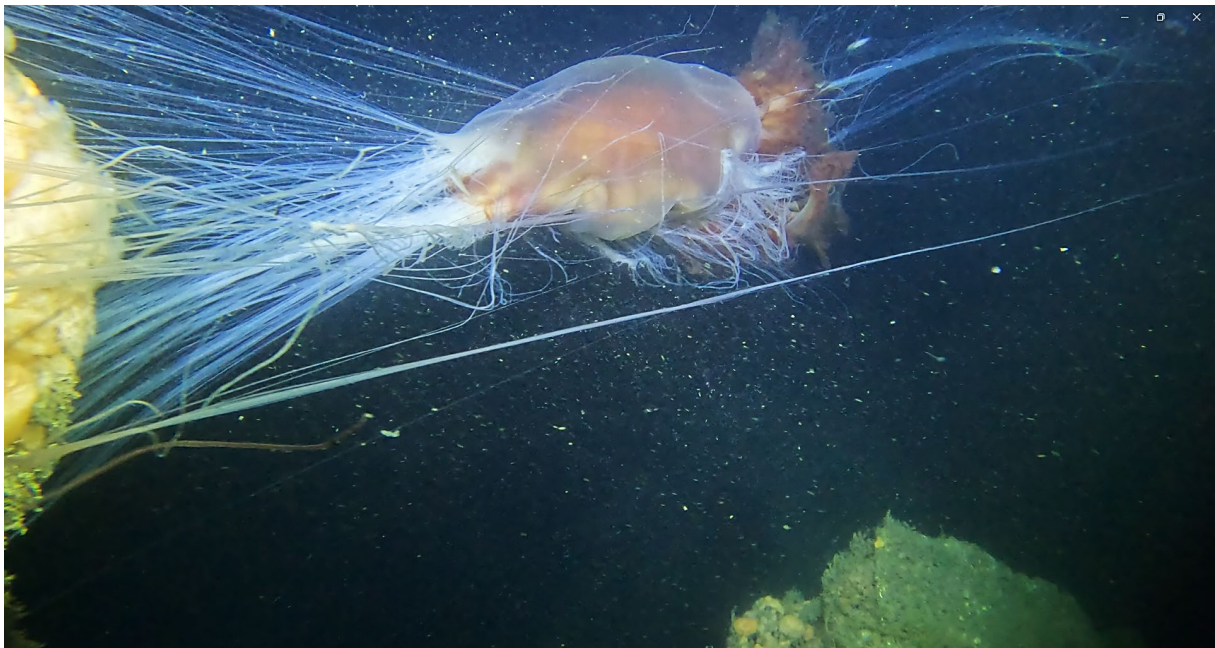
**Fig. 1.:** *Drifting in the dark. The jellyfish clinging to the stem of the ship shows the power of the currents (photo: Patrick Valkenborghs).*

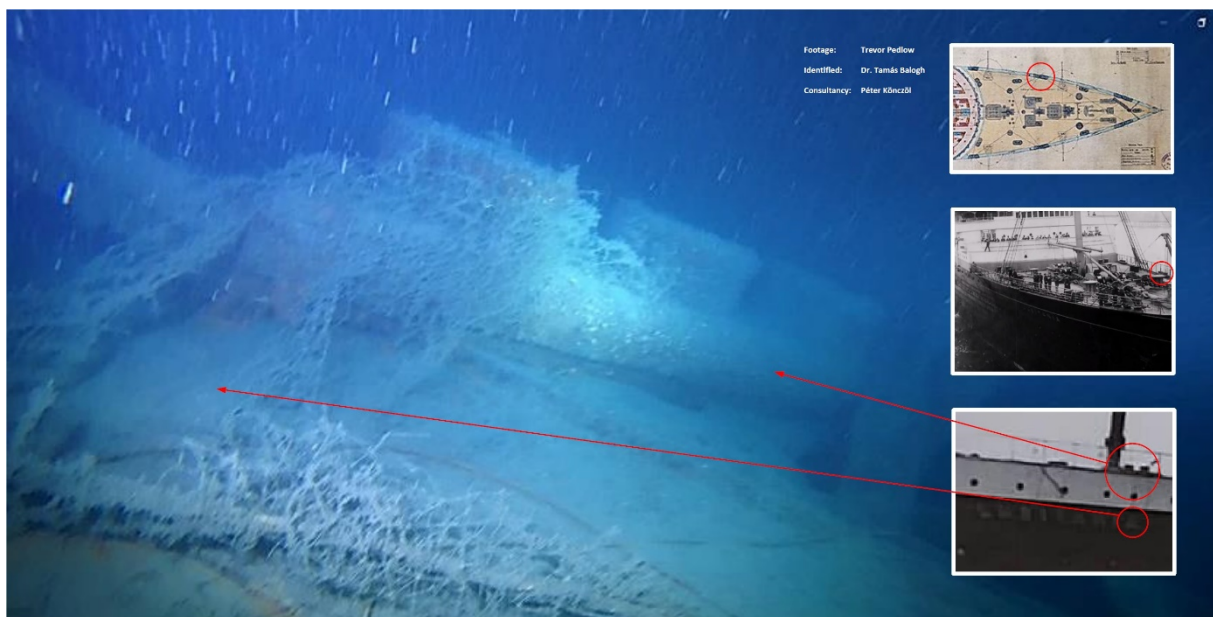
**Open doors accelerated the sinking not only under water, but also above it:** The divers identified the first two boarding doors on the portside plates of the bow section just in the line of the aft end of the boiler room № 1. Like those two doors identified by Robert D. Ballard in 1993 on the same deck but much further back, these two doors are also open. Since these doors could not be opened accidentally (their multiple securing prevented this), their open state clearly indicates that the crew opened them to facilitate the evacuation of passengers (trusting that through these doors would allow the passengers an easier way to enter the lifeboats which had been lowered from the boat deck in an empty state). Finally, the open doors were of no use in the rescue. However, the sinking of the ship was accelerated (similarly to the open coal-bunker doors in the boiler rooms), because as the water crossed the thresholds of these openings, it quickly started to flood the spaces above the ship's watertight deck, completely eliminating the ship's buoyancy.
